SITE DAMAGE TESTS OF GEOTEXTILES USED FOR LAYER SEPARATION IN ROAD CONSTRUCTION

Audrius Vaitkus¹, Alfredas Laurinavičius², Donatas Čygas³

Road Department, Vilnius Gediminas Technical University, Saulėtekio al. 11, LT-10223 Vilnius-40, Lithuania
E-mail: akml@ap.vtu.lt¹, alfla@ap.vtu.lt², dcyg@ap.vtu.lt³

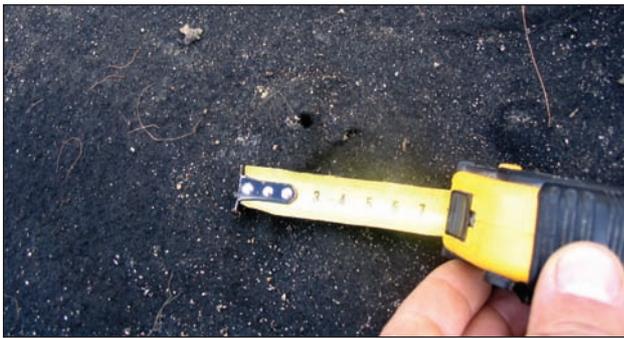
Fig 4. Samples of geotextile damages (puncturing) whose mass per unit area is 110 g/m² laid between the subgrade and the frost blanket course

- The geotextile whose mass per unit area was 110 g/m² had visually easily identifiable indentations and approx two punctures per m², their total area covering up to 2,5 cm²/m²;
- The geotextile whose mass per unit area was 130 g/m² had approx one puncture per m², its total area covering up to 2,2 cm²/m². There was also general abrasion noticed;
- The geotextile whose mass per unit area was 200 g/m² had insignificant indentations; no puncturing was identified;
- The geotextile whose mass per unit area was 300 g/m² had neither indentations nor puncturing.

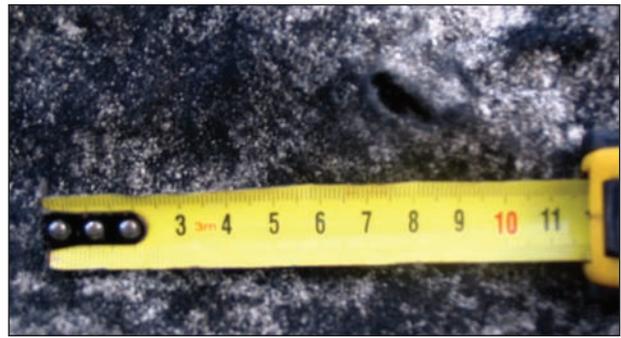
Fig 5. Samples of geotextile damages (puncturing) whose mass per unit area is 130 g/m² (laid between the frost blanket course and the sub-base of the pavement)

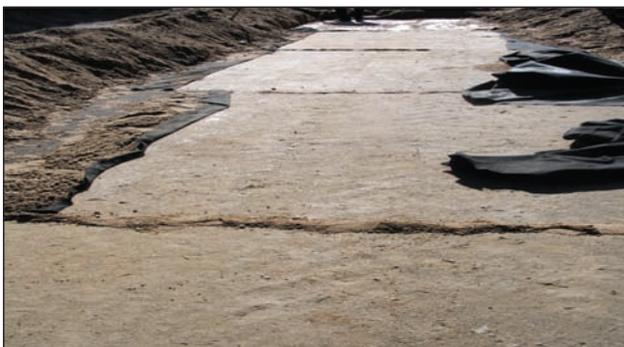
Fig 8. The performance of the road pavement layer separation by geotextile after uncovering the layers of the first test section of the pavement structure – the separation of the subgrade and the frost blanket course

The results of investigation indicate that all geotextile damages having occurred during the installation of road pavement layers over the geotextile had no significant impact on the pavement structure layer separation, one of major functions of geotextile. It can be easily noticed in Figs 8 and 9.

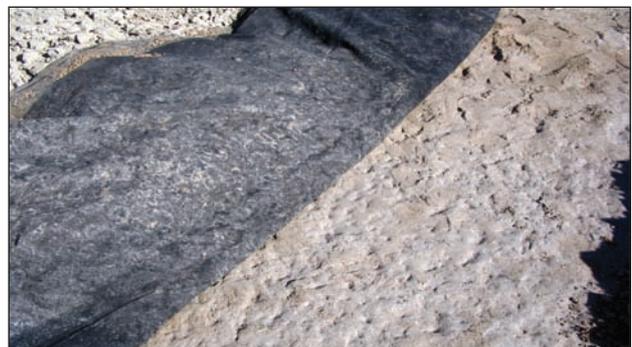
Fig 9. The performance of the road pavement layer separation by geotextile after uncovering the layers of the second test section of the pavement structure – the separation of the frost blanket course and the sub-base
