FIELD INVESTIGATION OF JOINTS IN PRECAST POST-TENSIONED SEGMENTAL CONCRETE BRIDGES

Abstract. The precast segmental construction is widely used in the bridge structures erected by balanced-cantilever method. The joints are obviously of the utmost importance in connecting the precast segments of bridge girders. As well as the girders, the joints between segments should be capable of transferring compression, shear, and torsion forces. The basic requirements for match-cast joints are summarised. The joints between segments in many precast concrete bridges constructed by balanced cantilever method were inspected during construction and in service. The results of field survey that are presented in this paper included 5 major bridges. The spans are all precast box girders of constant or varying cross-section. Studies were conducted to determine the geometry and mechanical properties of grouted and match-cast joints. Classification of joint defects is presented. Statistics are given on the defects observed in some box-girder segmental joints. Photographs of typical joint problems are included.

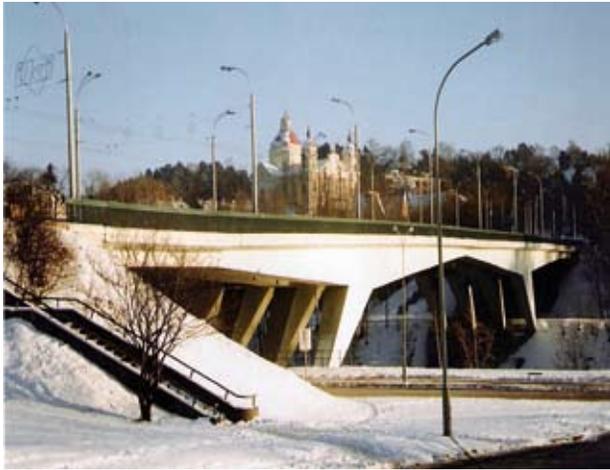
Fig. 1. One of the first PC precast segmental bridge with concrete joints over Neris River (bridged in 1965)

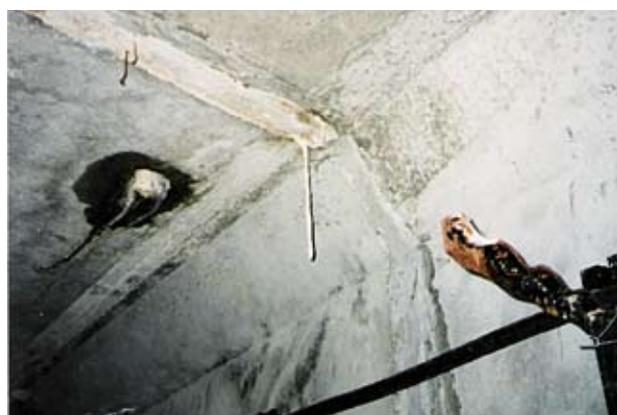
The results of survey showed that serious problem is leakage of joints to moisture and chlorides from the bridge deck causing prestressed tendons and anchors on the joints faces of the precast segments corrosion. The results of the inspections for inspected bridges showed that the joints appeared to have some leakage along with leaching coming from the top slab. Fig. 4 is a view of the underside of this joint. Schematic representation of the effect of leaching is also shown. Here water draining from the deck has found its way through the transverse joint followed by dis-

solving calcium hydroxide at joint locations with the result of staining, efflorescence, encrustation and stalactites.

Fig. 4. The effect of leaching on the underside of concrete deck of box girder due to leakage of epoxy joint

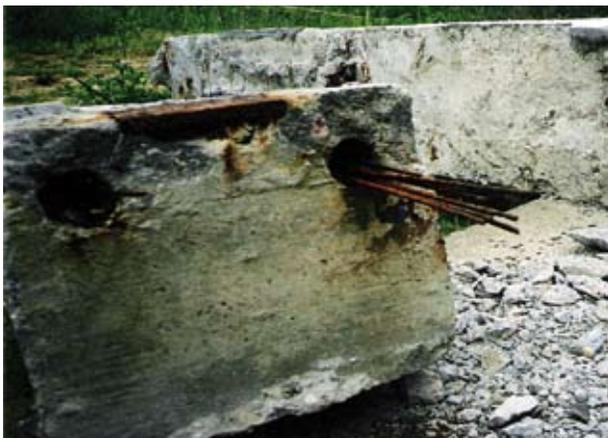
As an example, collapse without prewarning of bridge staircases for pedestrians due to prestressed tendons corrosion and rupture can be mentioned (Fig. 6). The joints between the central tower and the precast stairs were left without epoxy (dry joints) and the de-icing salts were used in abound. Fortunately, no loss of life was involved.

Fig. 6. Failure of bridge staircases due to corrosion of prestressed tendons in the dry joints

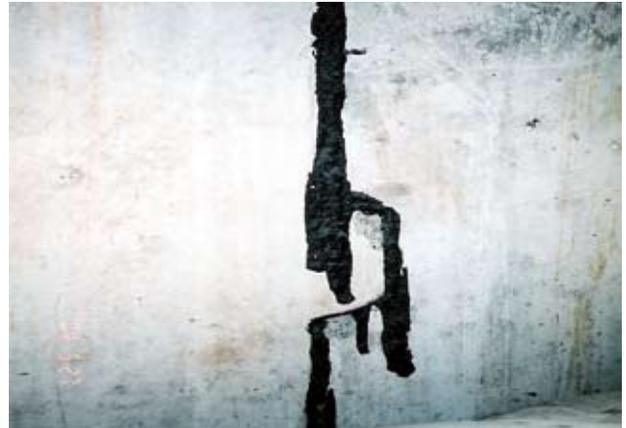
Fig. 7. Flowing out of the epoxy glue from the too large joint
