RESEARCH, ANALYSIS AND EVALUATION OF ROUNDABOUTS CONSTRUCTED IN LITHUANIA

Keywords: roundabout, inner radius, outer radius, carriageway width, structural defects.

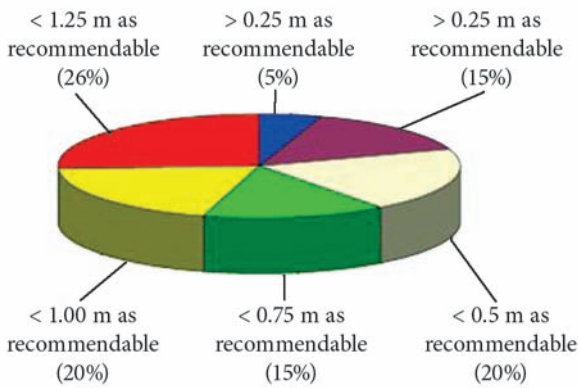
Fig. 5. Distribution of roundabouts by the carriageway width

Fig. 4 shows that in most cases the carriageway of roundabouts is narrower than the recommended one. Distribution of roundabouts by the carriageway width is given in Fig. 5.

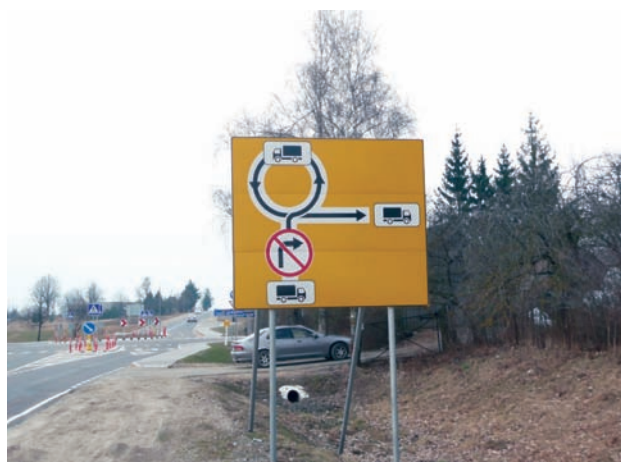
Fig. 7. The roundabout where the heavyweight vehicles are not able to make the right turn

ve the question on how to insert roundabouts into existing free territories. For this reason, the inner and outer radii as well as the entry and exit radii of roundabouts are minimum and do not meet the current requirements. One of such cases is shown in Fig. 7 where the heavyweight vehicles entering the roundabout are not able to make the right turn and have to go round the whole circle.

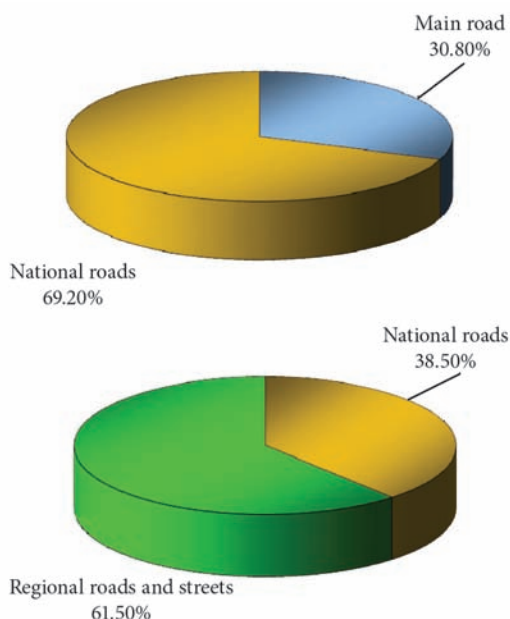
Fig. 8. The share of major and minor roads of roundabouts

Importance of the quality of road structures and their elements at the roundabouts could be emphasized by the fact that at present roundabouts are built on the major main and national roads. Since 2001, the major roads of roundabouts consist of main (30.8%) and national roads (69.2%). The minor roads of roundabouts are represented by national (38.5%) as well as regional roads and city streets (61.5%) (Fig. 8).

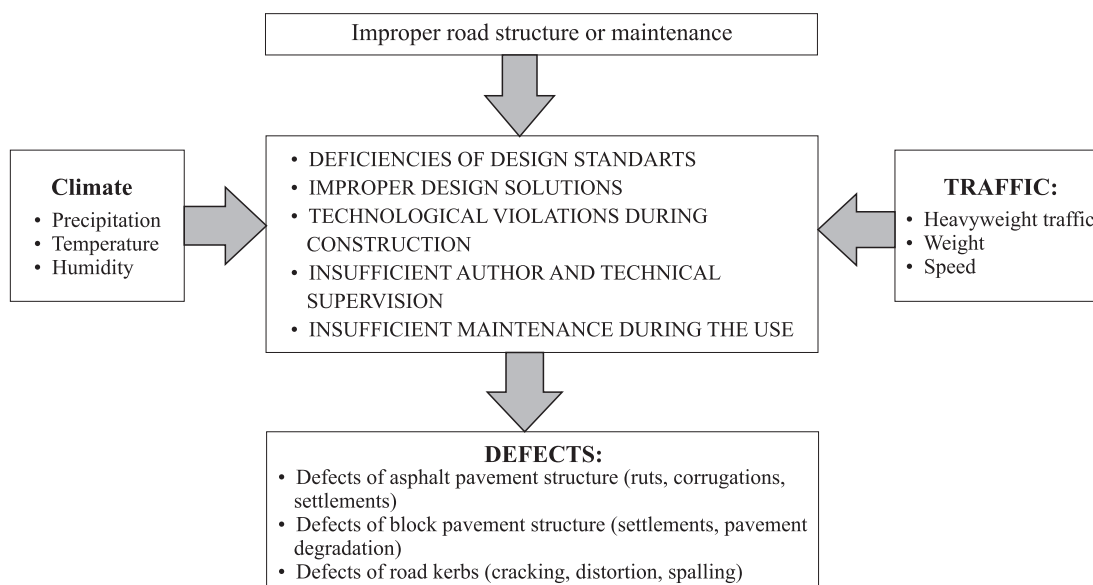
Fig. 9. Structural road defects and their causes

The process and the speed of structural degradation of roundabout pavements as and roads depend on the designed road structure, the quality of materials used, the condition of water discharge system, the impact of traffic and climatic factors, and on the level of maintenance (Fig. 9) (Grīslis 2010; Juknevičiūtė-Žilinskienė 2010; Petkevičius *et al.* 2010).

In the course of detail investigations the structural defects of block pavements were determined in some roundabouts (in the outer part of inner circle, in the entry and exit zones) which were caused by the unconformity of designed structures to traffic and structural strength, by the laying of block pavement and selection of the class of block pavement structure. It was determined that in case of unreduced strength of pavement base the block pavements are more sensitive to damages. When vehicles travel on such pavements the joints are subjected to damages (the fine filler of joints is pumped out), the blocs are moved off and in some cases even thrown to the surface, the pavement is destroyed, the settlements occur, the pavement profile is distorted, the pavement depressions accumulate water and the lower pavement structural layers are more intensively dampen (Fig. 9).

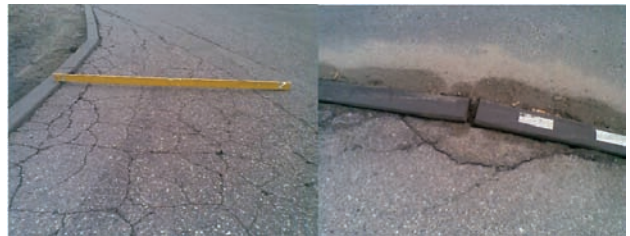
Fig. 10. Road structures damaged due to their unconformity to traffic and operational conditions

It happened, though very occasionally, that the roundabout road structure was damaged due to its unconformity to traffic and operational conditions (Fig. 10).

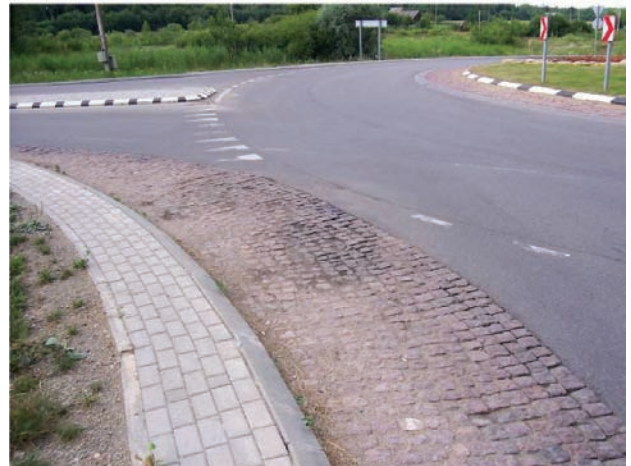
Fig. 11. The damaged block pavement on the widened carriageway

The mostly damaged elements are road kerbs both in the outer and in the inner part of the roundabout. They happen to be damaged even in a case when the block pavement structure has a sufficient strength (Fig. 11). The road kerbs become distorted (mostly in a part of the inner circle, the cracked or broken kerbs also could be find). Almost on all roundabouts the kerbs showed degradation

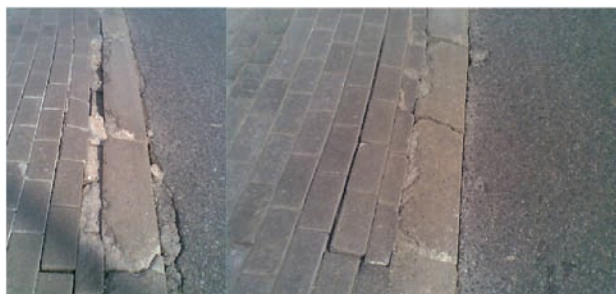
Fig. 12. Characteristic damages of road kerbs

defects, the damages of edges and other concrete surfaces. It was determined that the less damaged are the kerbs of safety islands. Characteristic damages of road kerbs are given in Figs 12 and 13.

The road kerbs of roundabouts shall be installed on concrete base having the corresponding height support from both sides of the kerb. Otherwise, when vehicles ride up on the kerbs they move off, break or crack at joints.

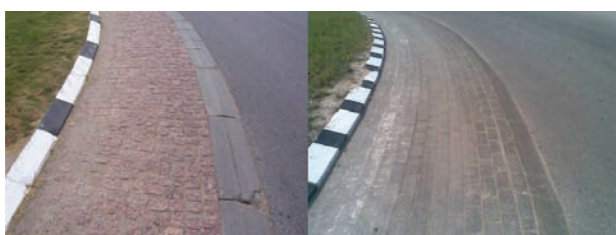
Fig. 13. The damaged road kerbs by riding up on the block-paved circle, the broken inner road kerbs at joints
